GEOTECHNICAL EVALUATION

Cinnamon Mountain Road
Mount Crested Butte, Colorado

**Project No. 21.6065
January 28, 2022**

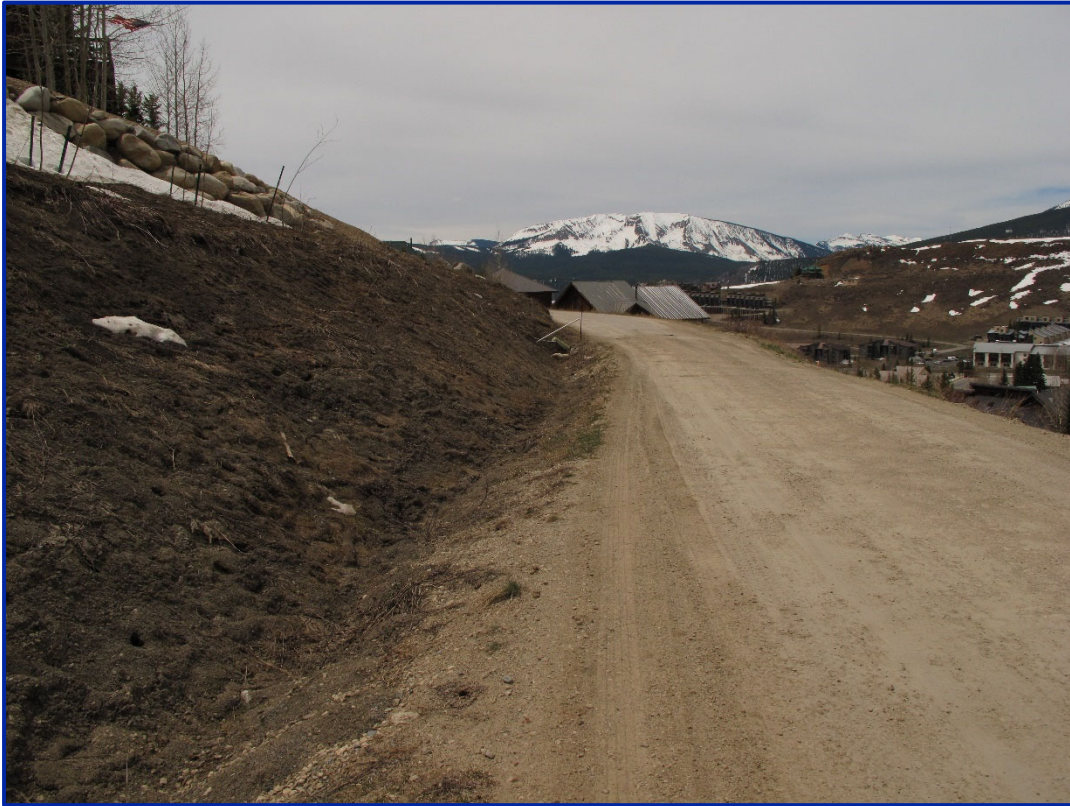
EXHIBIT 2. View looking south along Cinnamon Mountain Road on May 1, 2021.

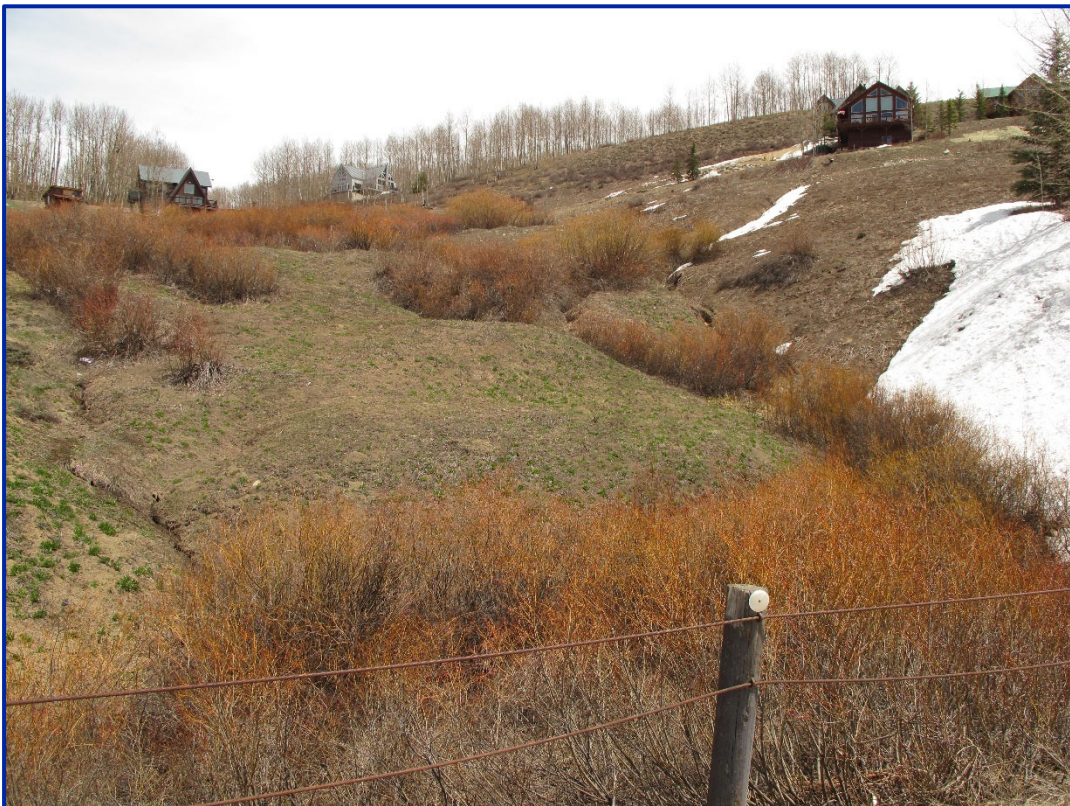
EXHIBIT 3. View looking east from Whetstone Road at hummocky terrain below Cinnamon Mountain Road on May 1, 2021.

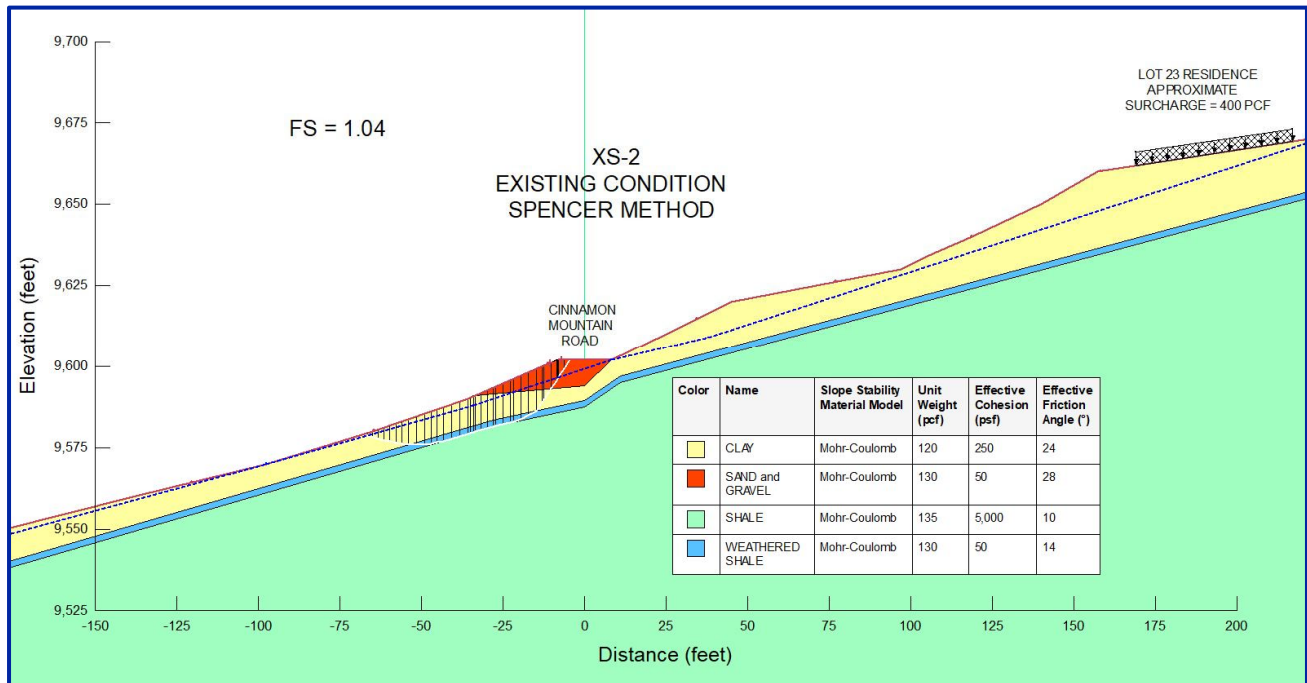
EXHIBIT 8. Results of GSA for the existing condition at Cross Section XS-2.

The results of the analysis indicate an FS of 1.04 for Cross Section XS-2 and an FS between 0.69 and 0.87 for the critical Cross Section XS-5, depending on the limits of analyses. The result shown in Exhibit 8 was given by nearly unbounded limits of analysis (i.e., the possible range in entrance of the slip surface extended as far upslope as the Landmark topographic survey provided). The result shown in Exhibit 10 was given by a slip surface entrance that was limited to the downslope (western) side

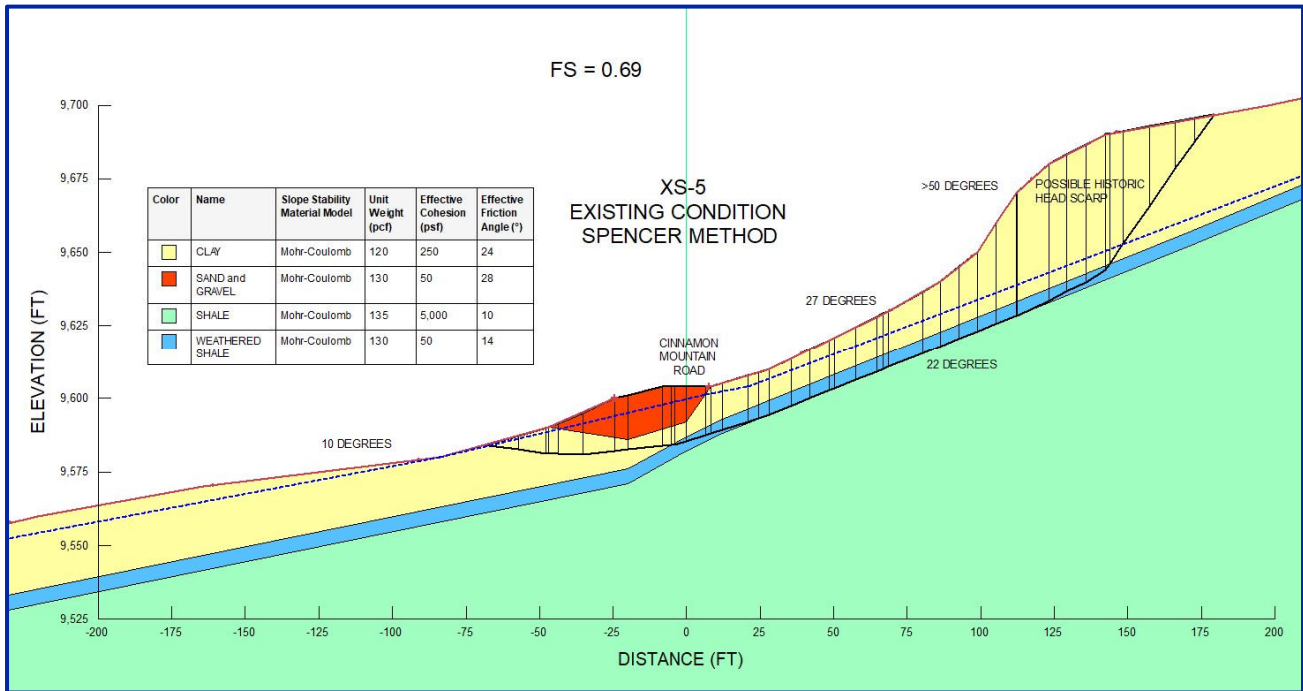
EXHIBIT 9. Results of GSA for the existing condition at Cross Section XS-5.

of the prominent, possible, historic scarp. The difference in the FS is significant with a value of 0.69 for the unbounded case and a value of 0.87 where the slip surface entrance was limited to the downslope of the historic scarp. Such limitations on the range of analyses may be justifiable if they are based on the movement history of the site (e.g., signs of movement were not observed by Cesare near the prominent, possible, historic scarp of Exhibit 10). However, limitations on the range of analyses are typically not needed when the subsurface profiles are better known across the site. Cesare recommends that updated GSA for the existing condition be performed based on additional subsurface exploration downslope and especially upslope of Cinnamon Mountain Road, rather than the assumed subsurface profiles presented herein.

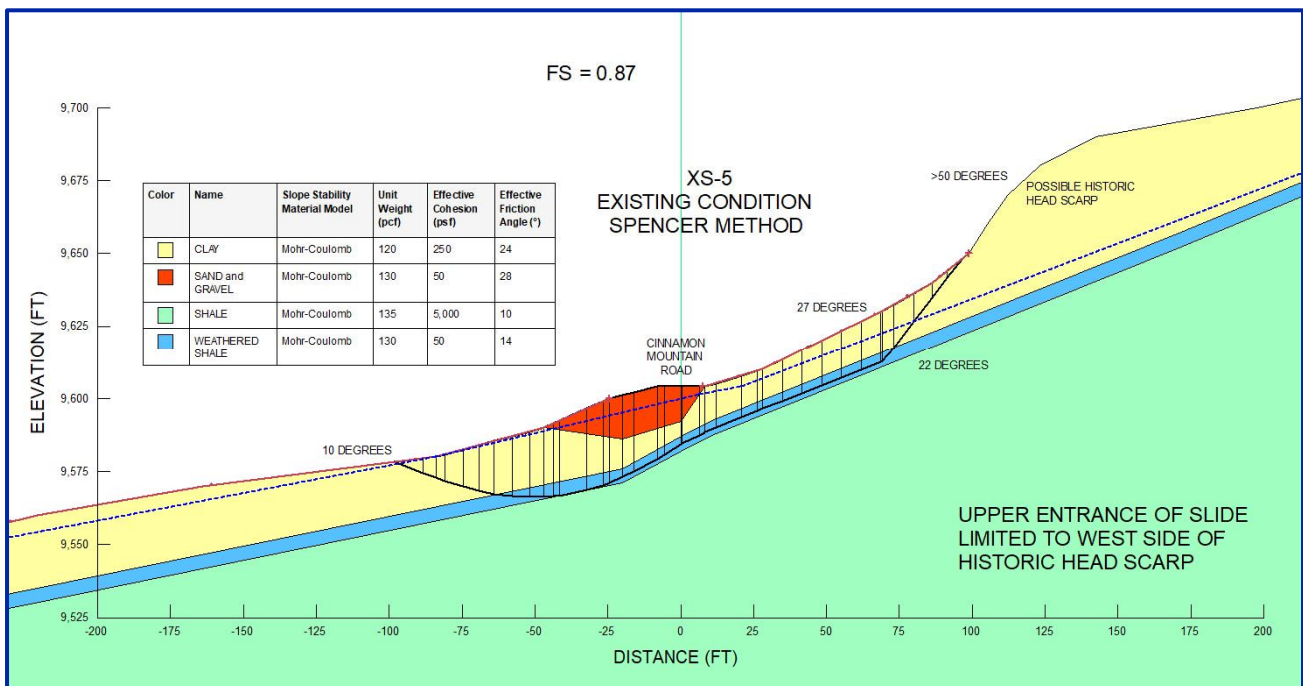
EXHIBIT 10. Results of GSA for the existing condition at Cross Section XS-5 with slide entrance limited to the western side of the possible historic scarp.

Because the subsurface profiles and topography varies, the FS is expected to vary with the cross sections across the site. Typically, lower FS's are given by steeper cross sections. If the result of Exhibit 10 (the analysis limited to the western side of the historic scarp) is taken to be representative of the critical cross section then the average FS between XS-2 and XS-5 is 0.96, which is slightly less than 1.0 inch and considered a reasonable representation of the existing conditions.

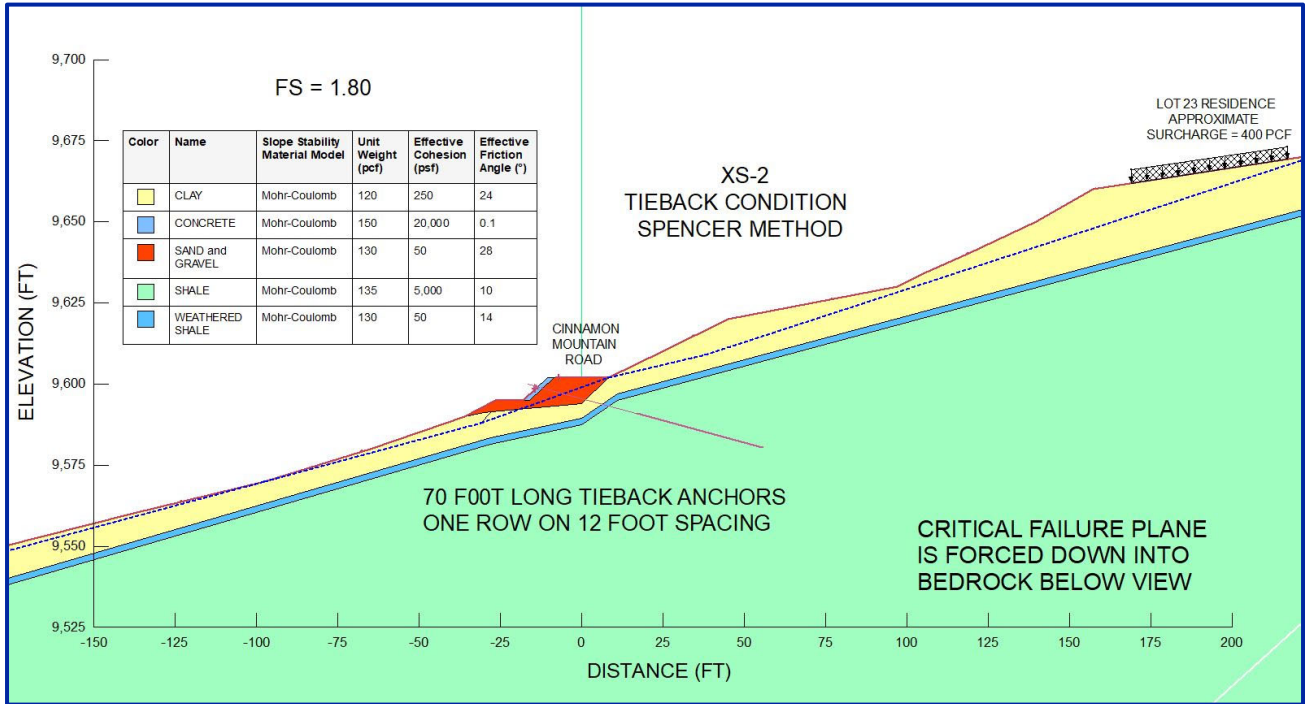
EXHIBIT 11. Results of GSA for a proposed tieback condition at Cross Section XS-2.

Based on the assumed subsurface profiles, the assumed extents of the existing slide, and the analyses performed, Cesare estimates that the number of 70 to 85 foot long tieback anchors required to stabilize the roadway will be on the order of 60 to 100, depending on the findings of additional subsurface exploration and slope monitoring. Cesare estimates that the anchors will need to be installed in one to three rows along the downhill side of Cinnamon Mountain Road with either discrete concrete panels or continuous shotcrete as indicated by Exhibits 11 through 13.

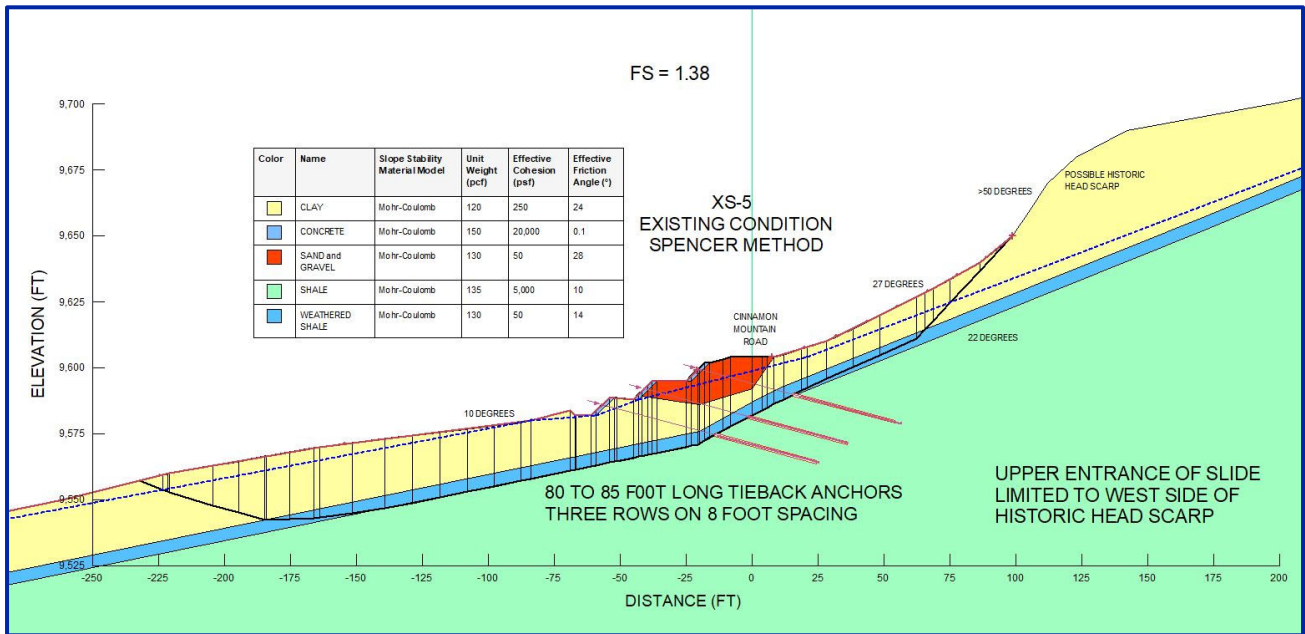
EXHIBIT 12. Results of GSA for the existing condition at Cross section XS-5 with slide entrance limited to the western side of the possible historic scarp.

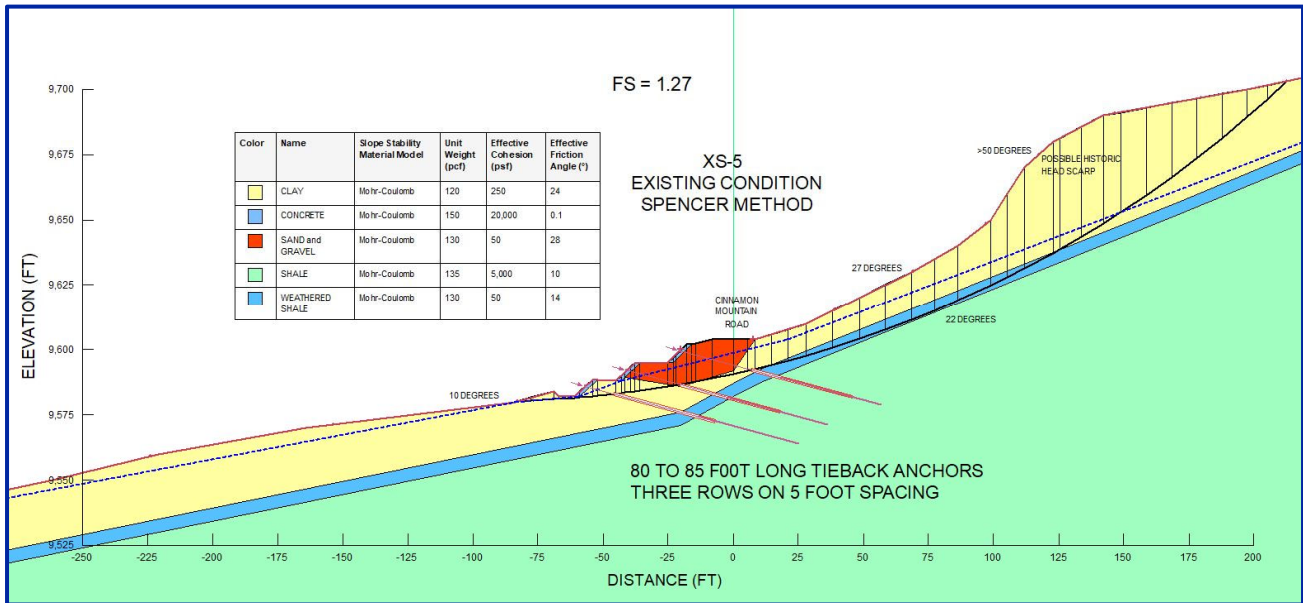
EXHIBIT 13. Results of GSA for a proposed tieback condition at Cross Section XS-5 with unbounded limits of analysis (i.e., the entrance of the slip surface extends beyond the historic scarp).
