GEOTECHNICAL EVALUATION

Cinnamon Mountain Road
Mount Crested Butte, Colorado

**Project No. 21.6065
January 28, 2022**

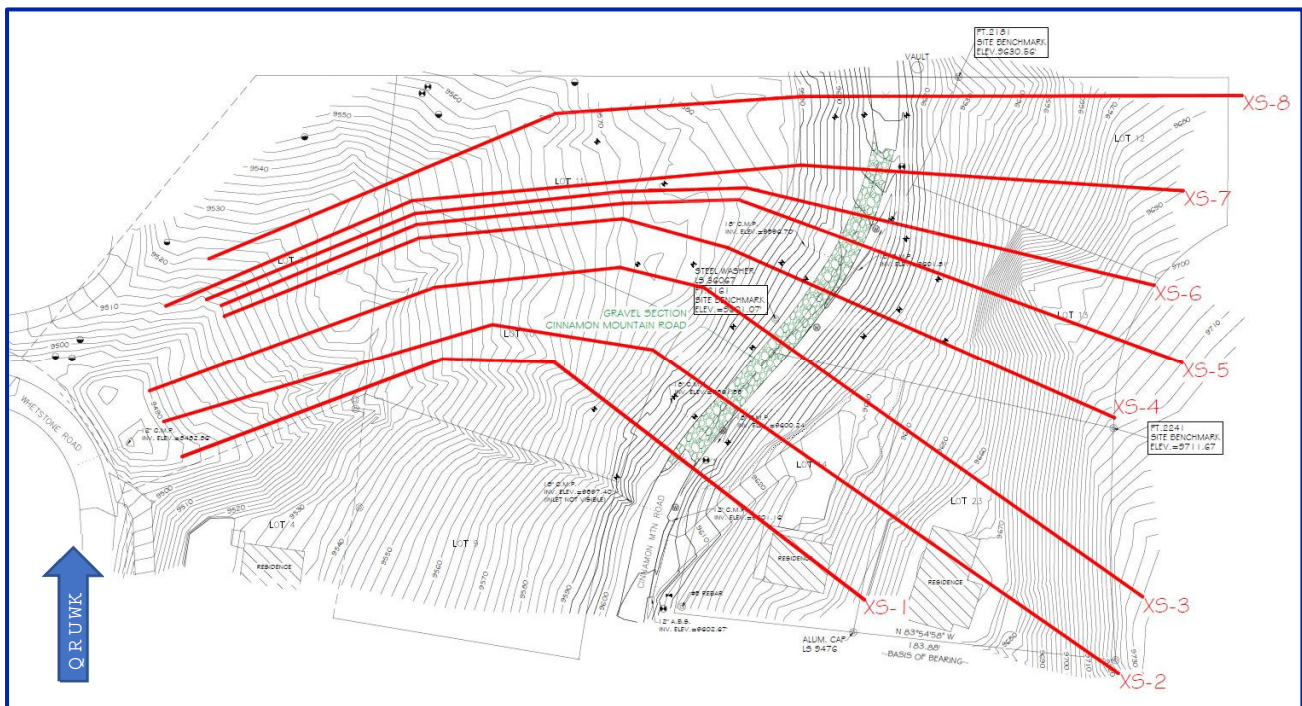
EXHIBIT 4. Cesare cross sections superimposed on Landmark topographic map.

Cesare reviewed the topographic map and developed eight cross sections over the site designated as XS-1 through XS-8. The cross sections were made at about 20 to 60 foot intervals along Cinnamon Mountain Road as indicated by Exhibit 4.

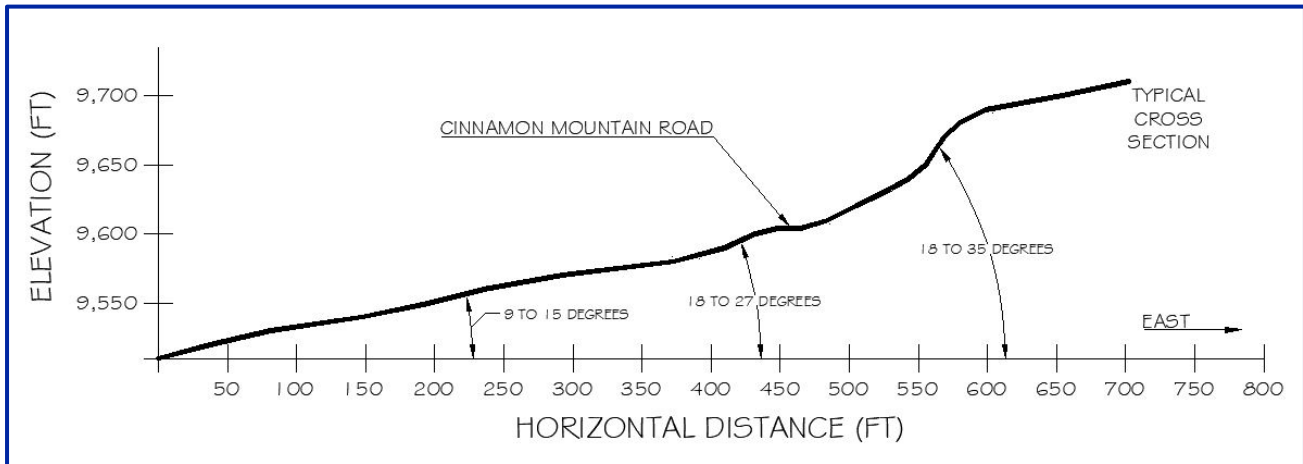
EXHIBIT 5. Typical cross section developed from topographic map.

- C the angle of the terrain upslope of Cinnamon Mountain Road was found to vary between about 18 and 35 degrees,
- C the angle of the roadway fill embankment between about 50 and 100 feet downslope of Cinnamon Mountain Road was found to vary between about 18 and 27 degrees, and
- C the angle of the overall slope downslope of the roadway fill embankment was found to vary between about 9 and 15 degrees (see Exhibit 5).

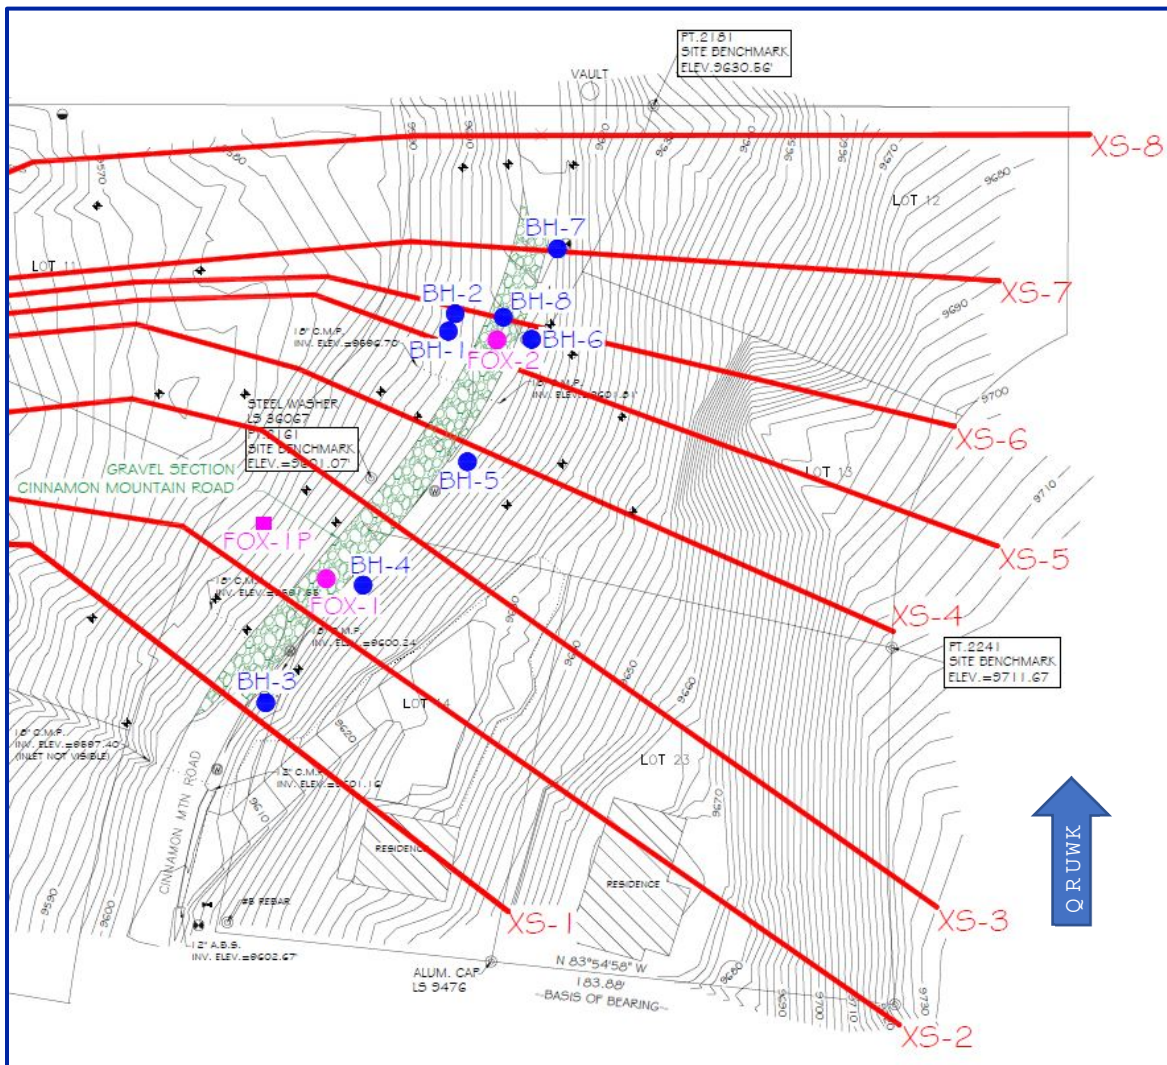
EXHIBIT 6. Approximate exploratory boring and pit locations by Fox and Buckhorn.

Buckhorn advanced eight borings through or near Cinnamon Mountain Road between July 16 and 18, 2008. The borings are designated as BH-1 through BH-8 and the approximate locations are shown in Exhibit 6. Borings BH-1 and BH-2 were advanced downslope of the roadway. Boring BH-8 was advanced through the roadway near Fox's Boring FOX-1. Borings BH-3 through BH-7 were advanced adjacent to the roadway on the uphill (east) side. Buckhorn's boring location map and logs are included in Appendix D.

Buckhorn installed a full depth inclinometer in Boring BH-1 to monitor slope movement and open standpipe piezometers in Borings BH-2 through BH-8 to monitor groundwater levels.
